Evaluation of Thermoplastic Marking Materials

May 2008

DOT/FAA/AR-TN08/22

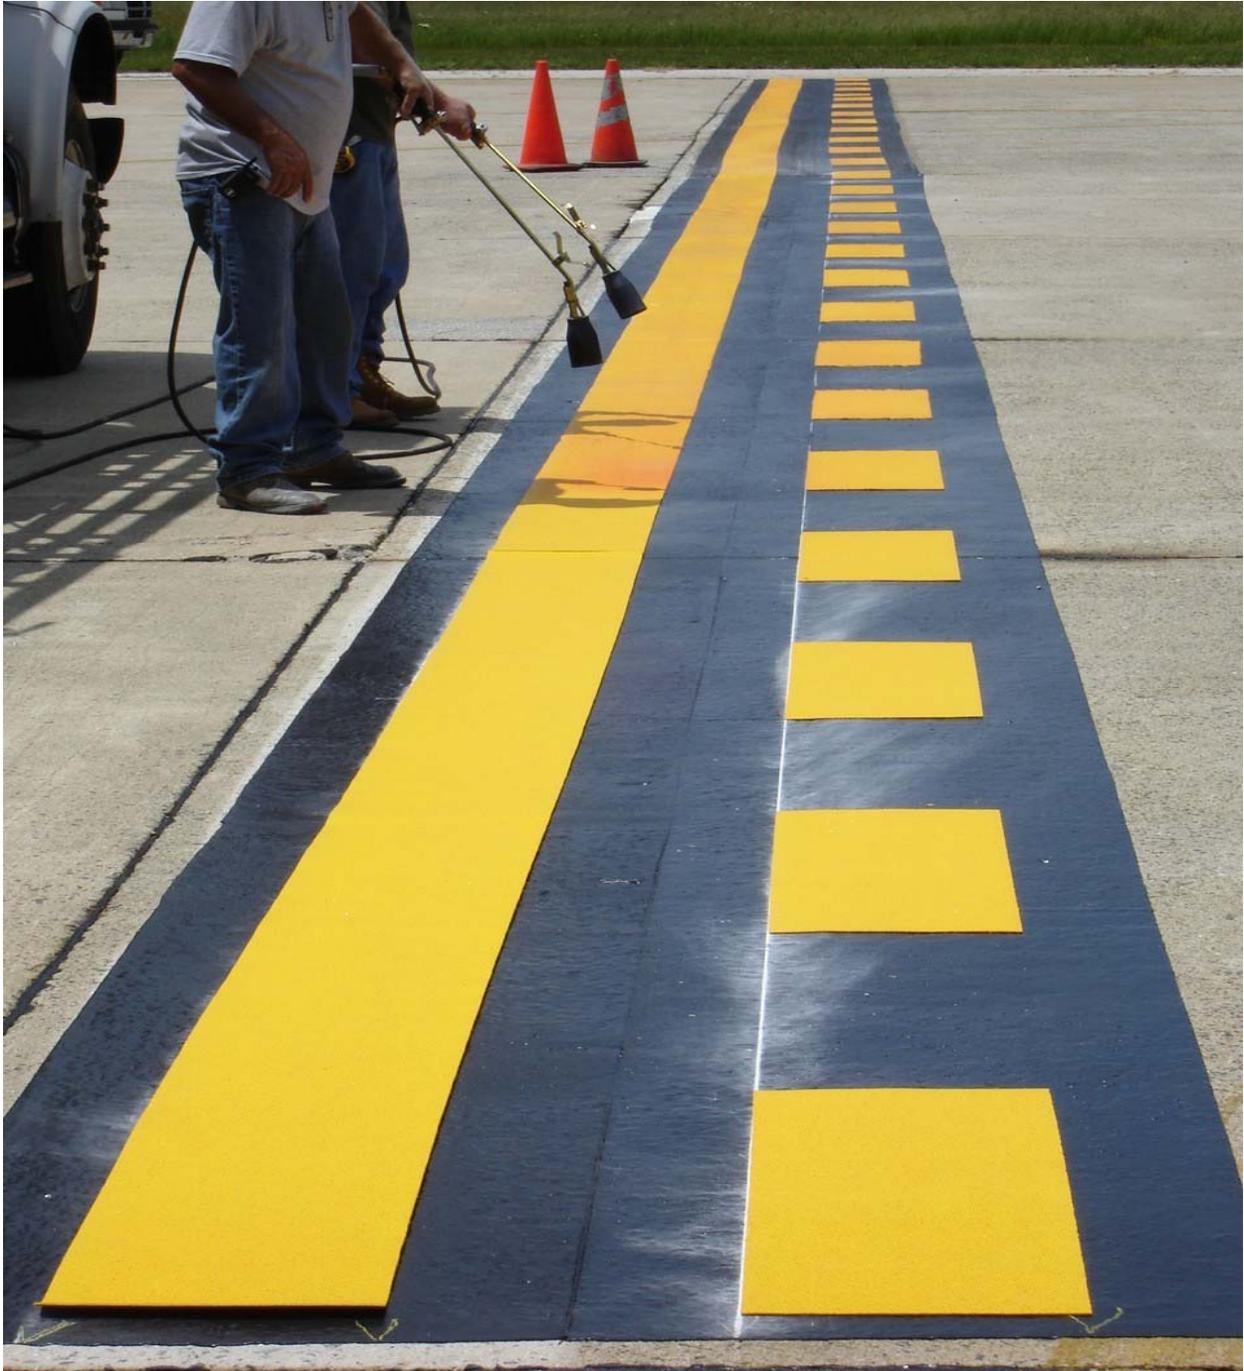
Installation of thermoplastic material first occurred on an aged PCC test area using direct open flame wands to heat the material. The movement/nonmovement marking is shown in figure 1.

Figure 1. Movement/Nonmovement Line on PCC at FAA William J. Hughes Technical Center

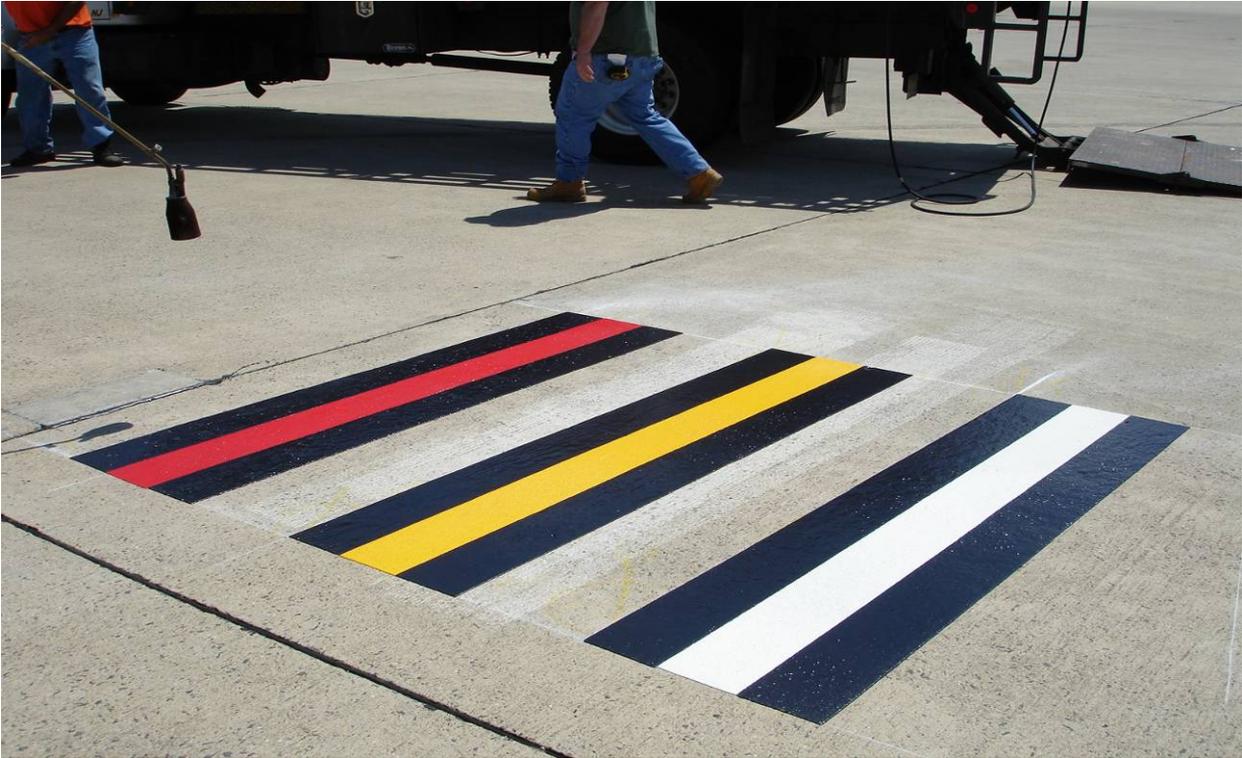
Three-foot red, yellow, and white stripes are shown in figure 2. Aircraft parking numbers were applied as shown in figures 3, 4, and 5, using both a large area radiant heater and direct open flame wands to heat the material. The thermoplastic material markings were applied afterward on HMA. Three-foot red, white, and yellow stripes were applied, as shown in figure 6, and 150'-long white stripes were applied, as shown in figure 7.

Figure 2. Red, Yellow, and White Stripes on PCC at FAA William J. Hughes Technical Center

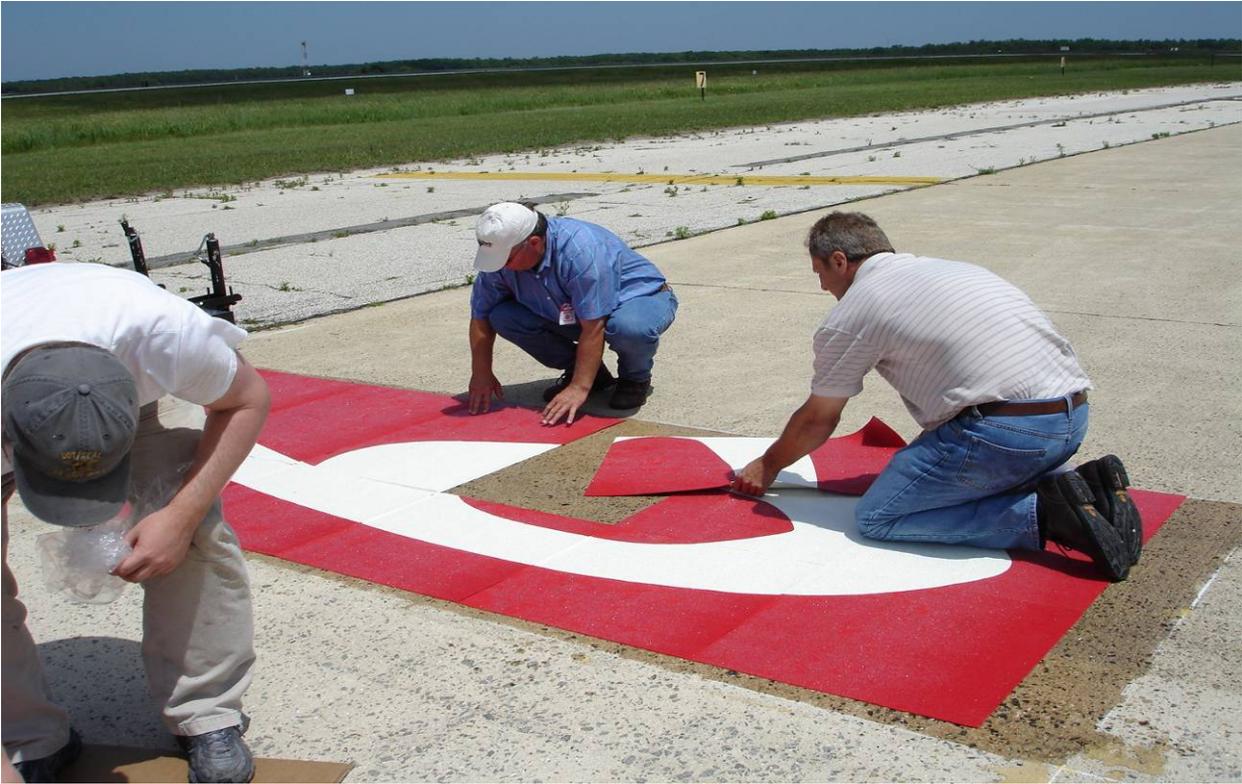
Figure 3. Aircraft Parking Location #6 on PCC at FAA William J. Hughes Technical Center

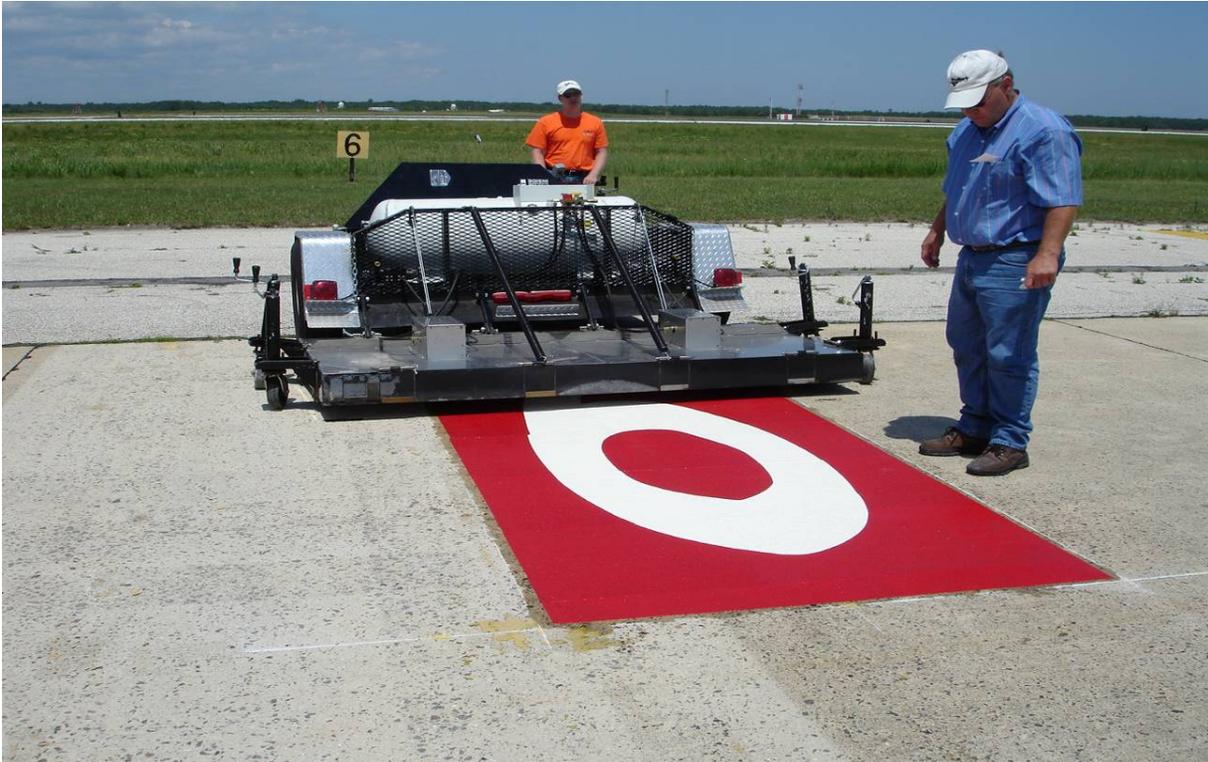
Figure 4. Heating Aircraft Parking Location #6 on PCC at FAA William J. Hughes Technical Center

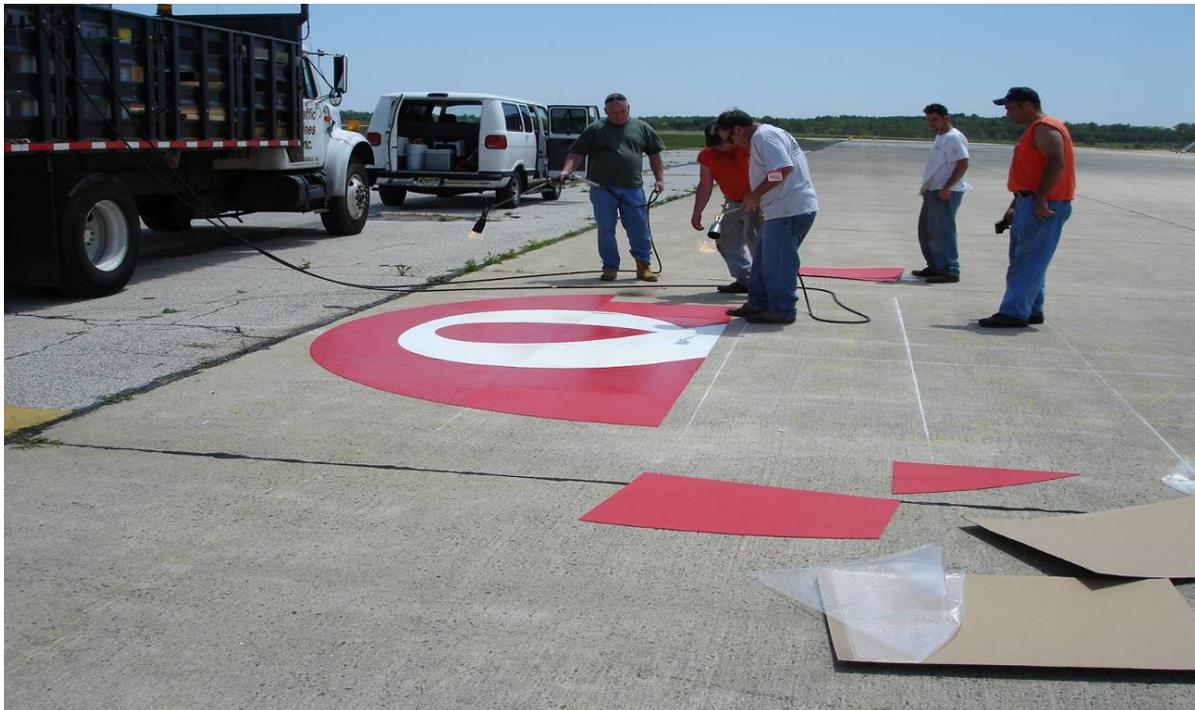
Figure 5. Aircraft Parking Location #8 on PCC at FAA William J. Hughes Technical Center

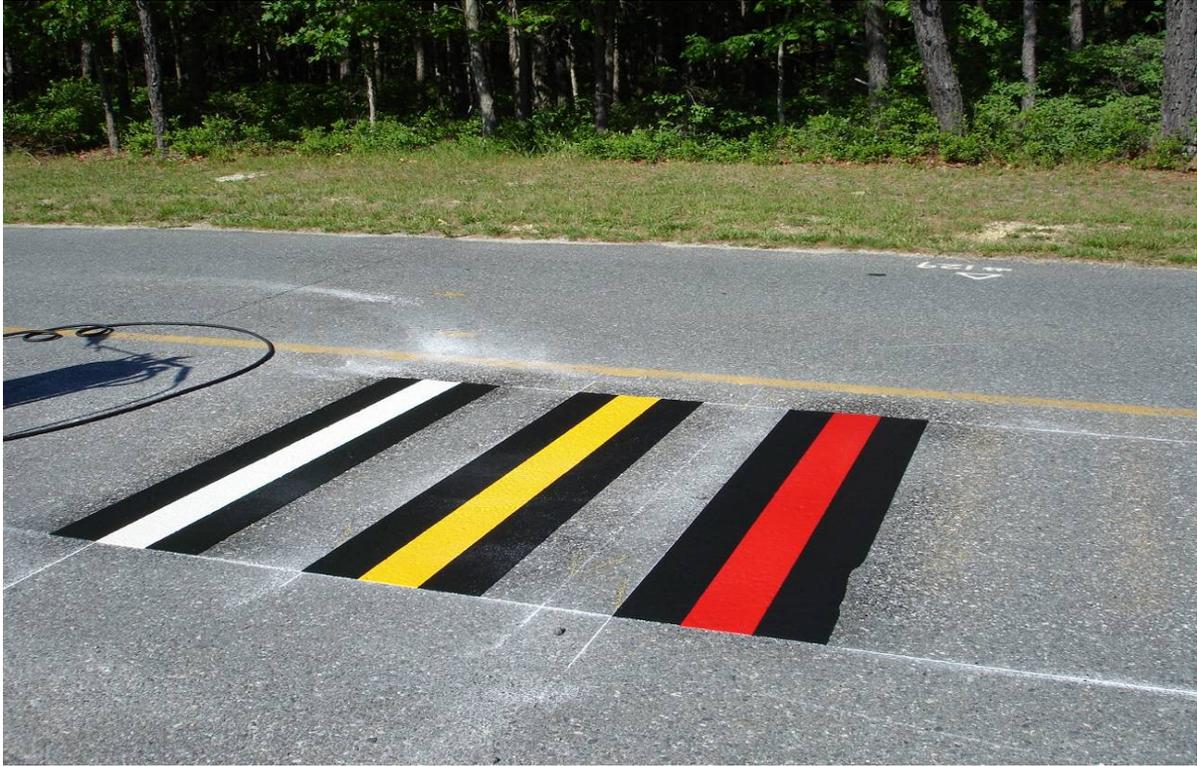
Figure 6. White, Yellow, and Red Stripe on HMA at FAA William J. Hughes Technical Center

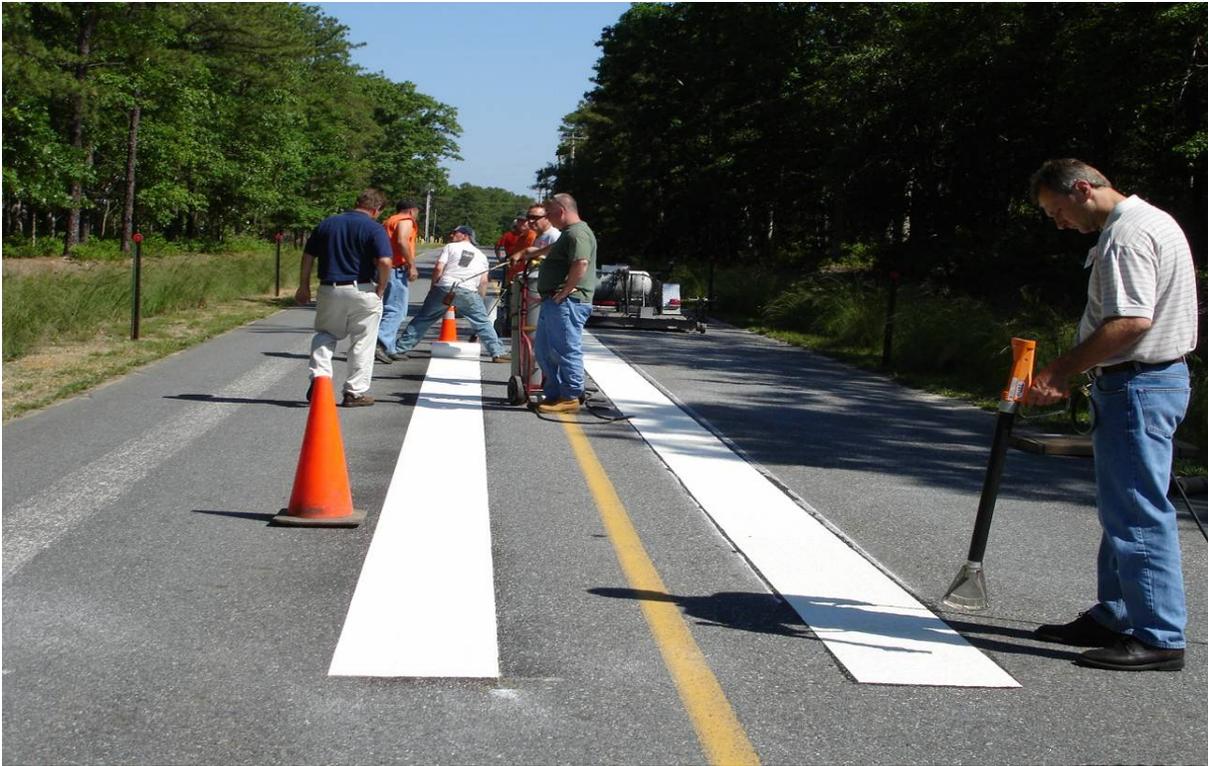
Figure 7. A 150-Foot White Stripe on HMA at FAA William J. Hughes Technical Center

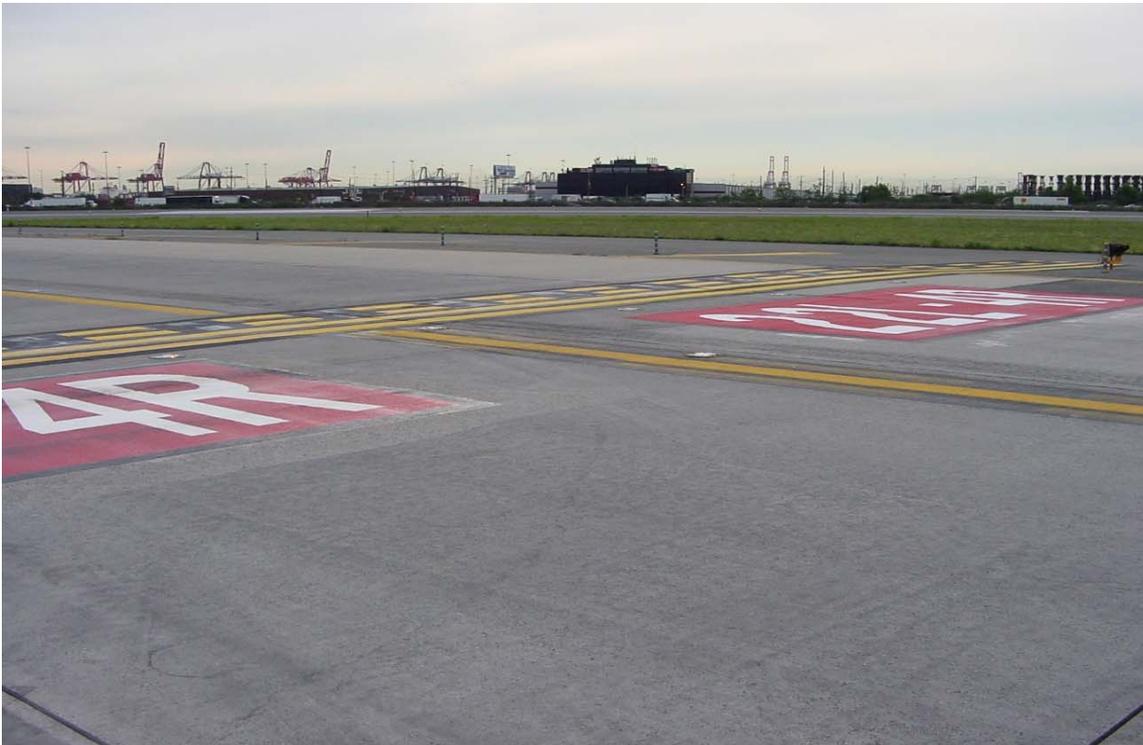
Figure 8. Side-by-Side Markings at EWR

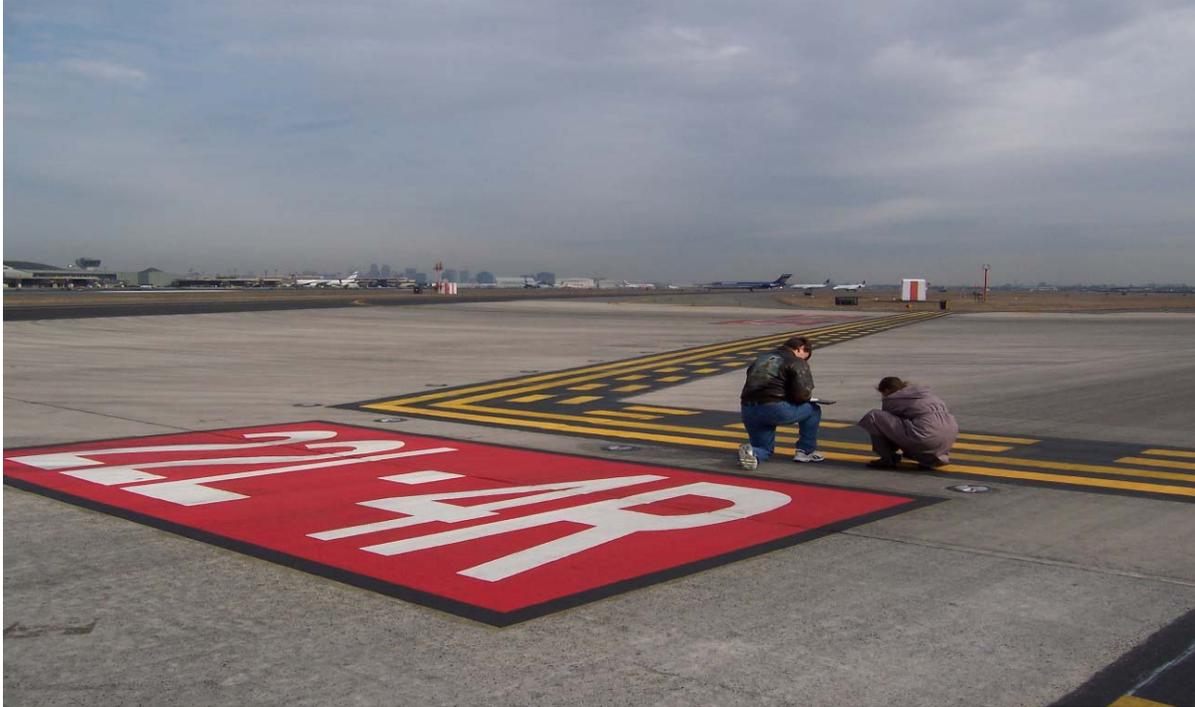
Figure 9. Thermoplastic Runway Identification Marking and One Solid Yellow Line of the Runway Holding Position Marking

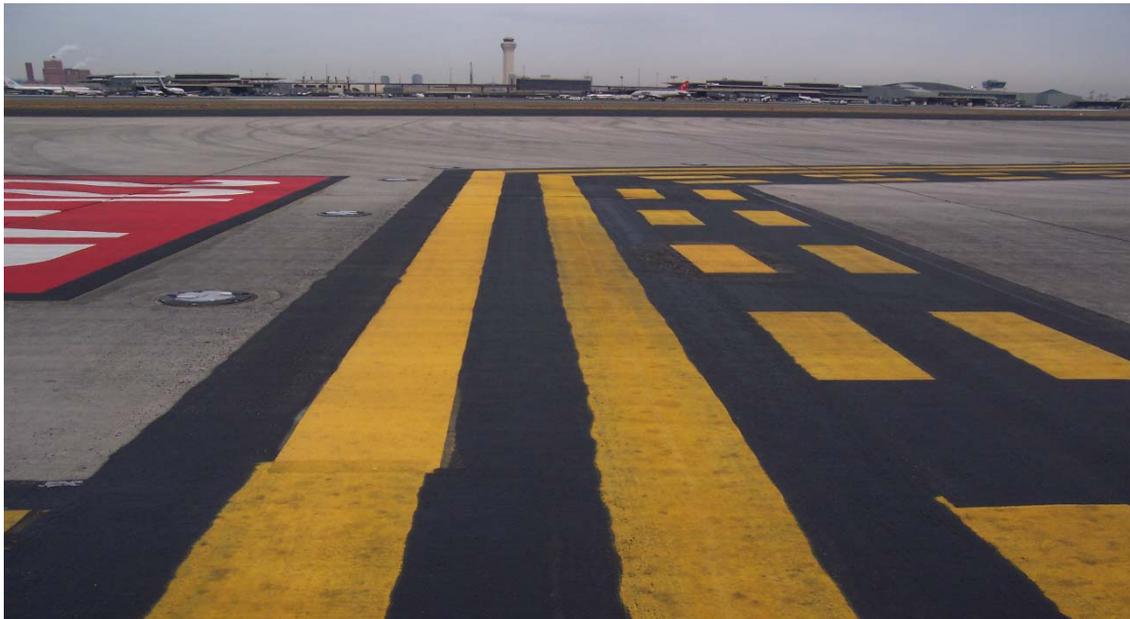
Figures 10, 11, and 12 show the various thermoplastic markings that were applied to PCC on taxiway November. Figure 11 shows the thermoplastic dashed yellow line marking in which the double-drop method for applying beads was performed.

Figure 10. Thermoplastic Solid Yellow Line of Runway Holding Position Marking at EWR

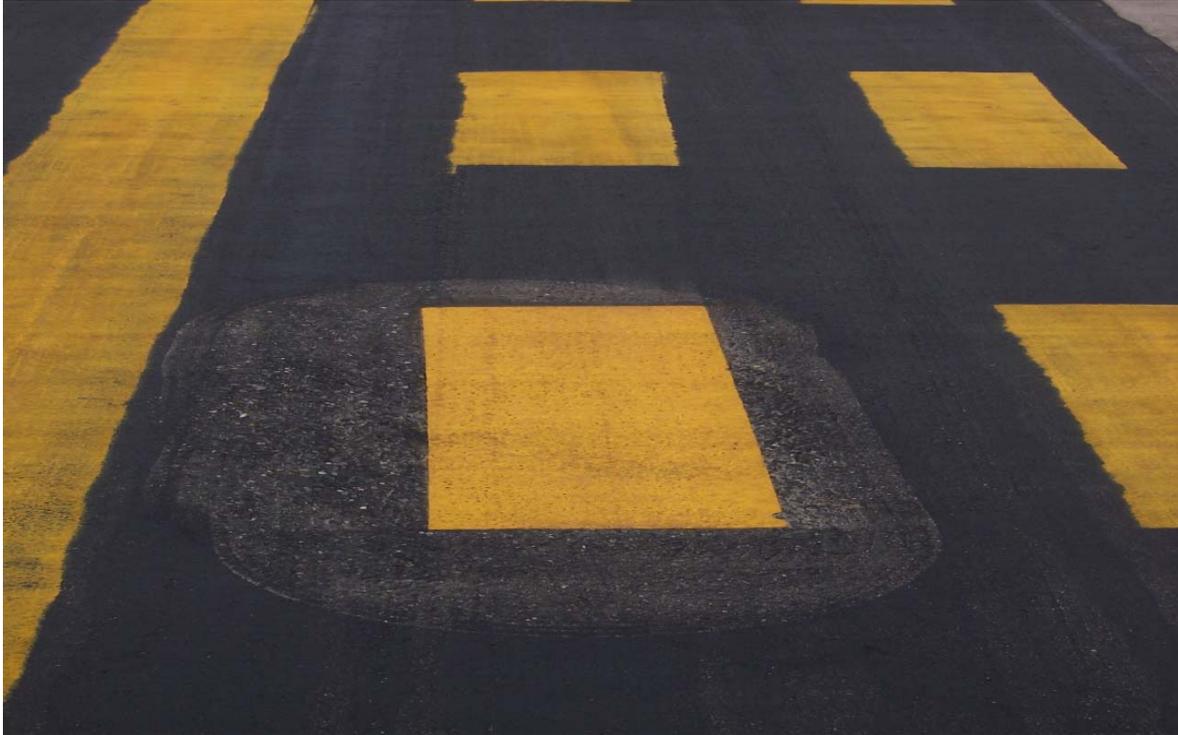
Figure 11. Thermoplastic Dashed Yellow Line of Runway Holding Position Marking at EWR

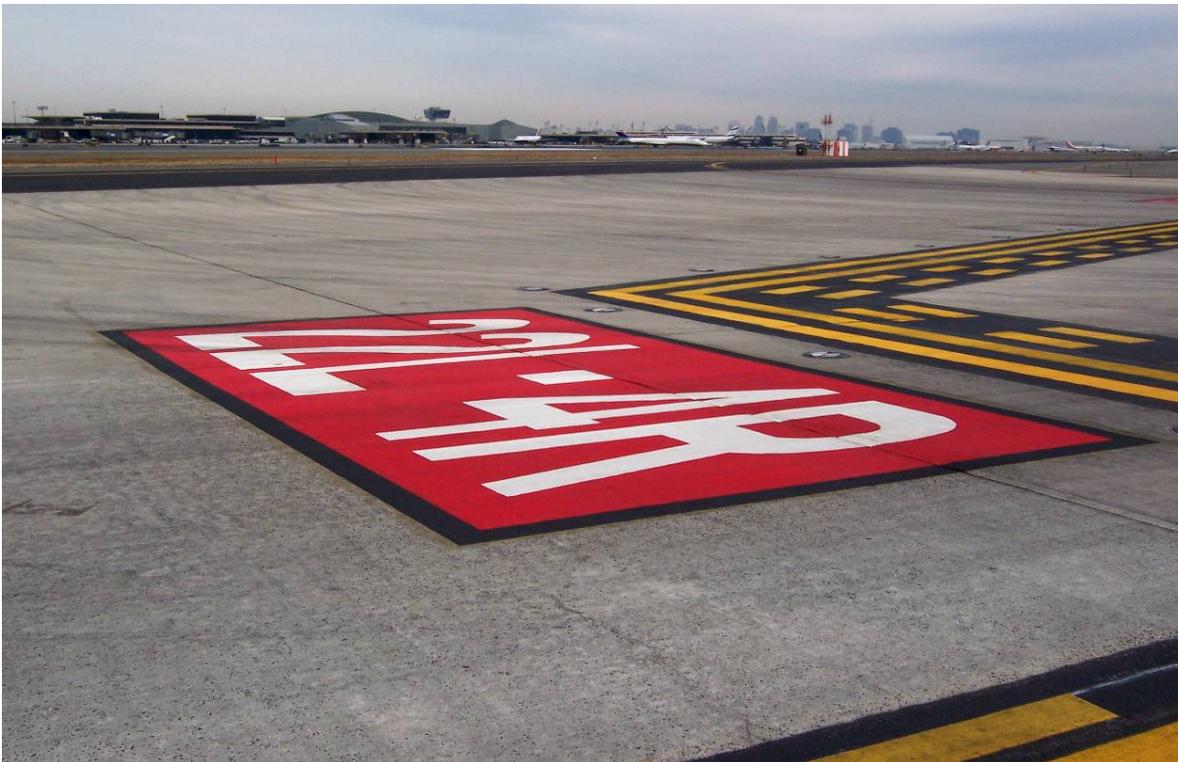
Figure 12. Thermoplastic Runway Identification Marking at EWR

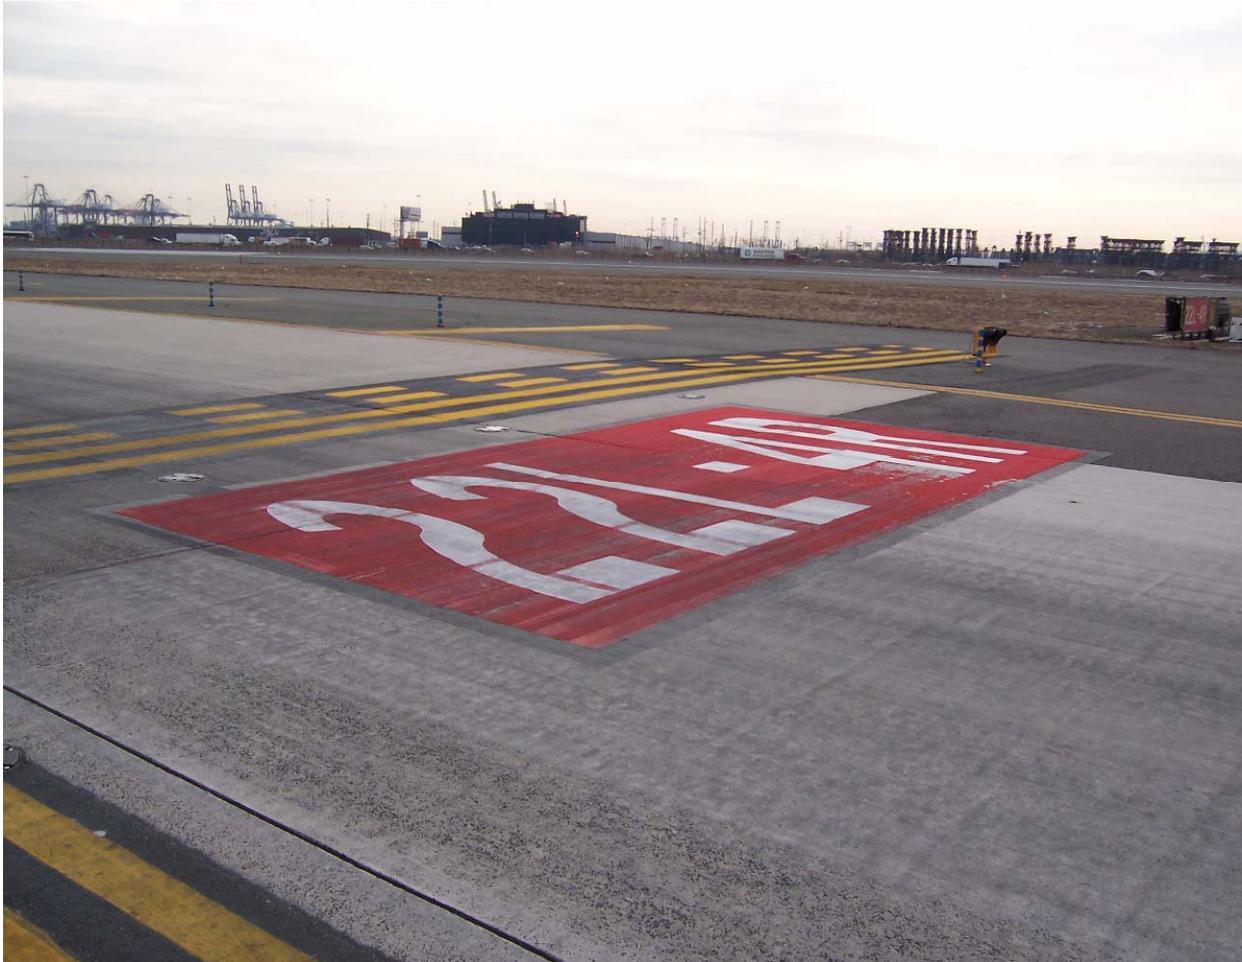
To assist in Phase 2 of the evaluation, EWR maintenance personnel duplicated the same type of markings as the thermoplastic markings using standard waterborne paint, as shown in figure 13. These markings were painted adjacent to the thermoplastic markings to ensure the same amount of aircraft movements crossed over both the thermoplastic and waterborne paint markings. Table 4 lists the type of markings painted, the type of beads, and the marking designation.

Figure 13. Standard Waterborne Painted Runway Identification Marking at EWR

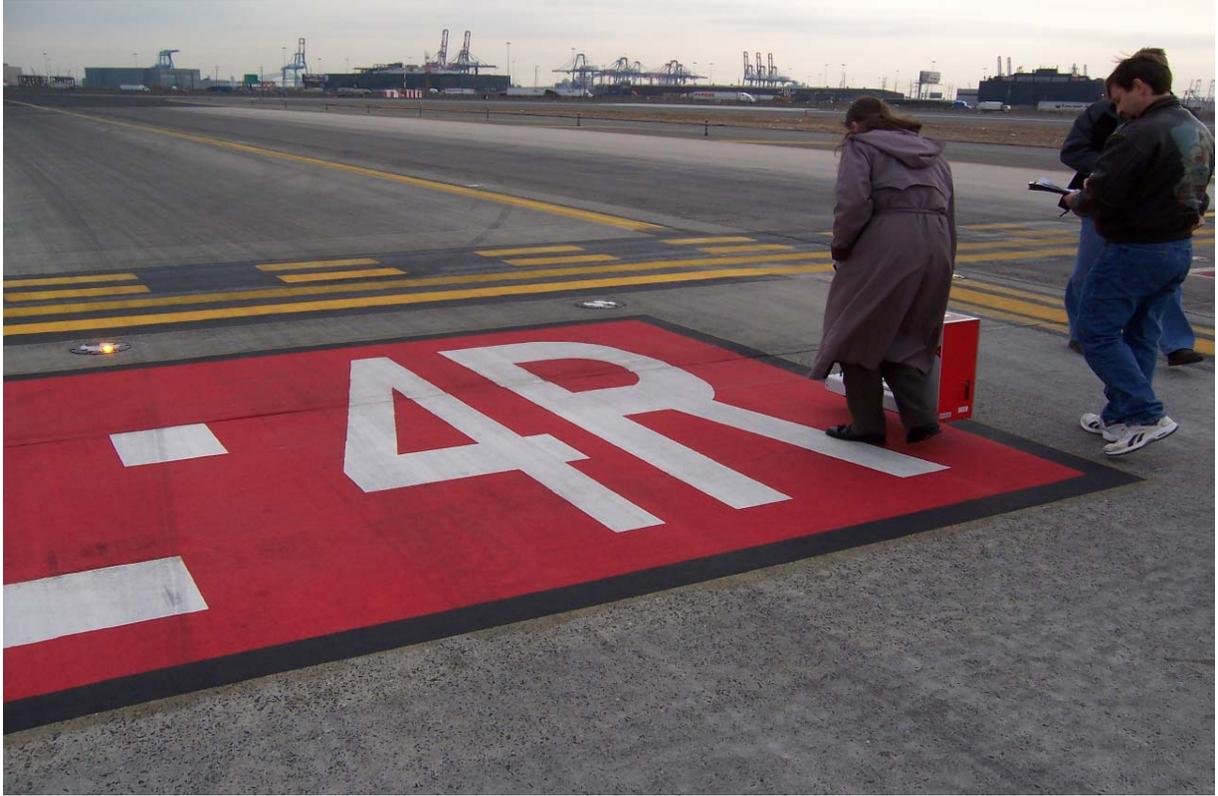
Photographs of the runway identification marking, as shown in figures 14 and 15, represent the deterioration starting on the various markings after only 6 months of testing.

Figure 14. Thermoplastic Marking Material After 6 Months at EWR

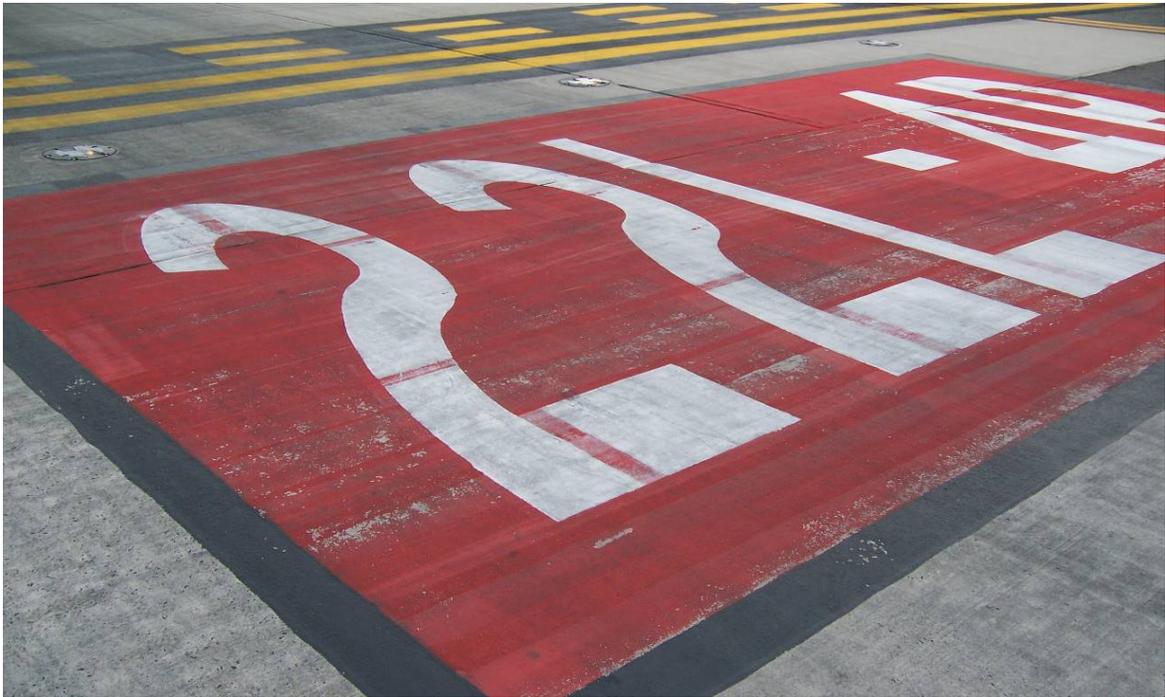
Figure 15. Standard Waterborne Paint After 6 Months at EWR

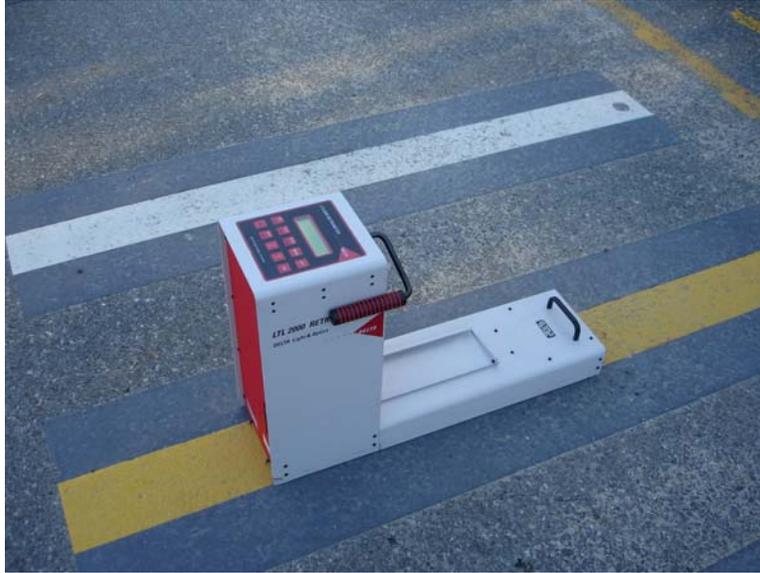
Figure 18. Retro-Reflectometer, 30-Meter Geometry for Measuring Retro-Reflectivity of the Glass Beads

The retro-reflectometer produced millicandela per meter squared per lux readings. Currently, the FAA has no standard for retro-reflectivity limits. A previous paint marking study conducted by the FAA Airport Safety Technology Research and Development Section determined that the recommended minimum was 100 mcd/m²/lx for white and 70 mcd/m²/lx for yellow. The color red was not studied as part of this previous effort. Reference 2 elaborates on this test method.

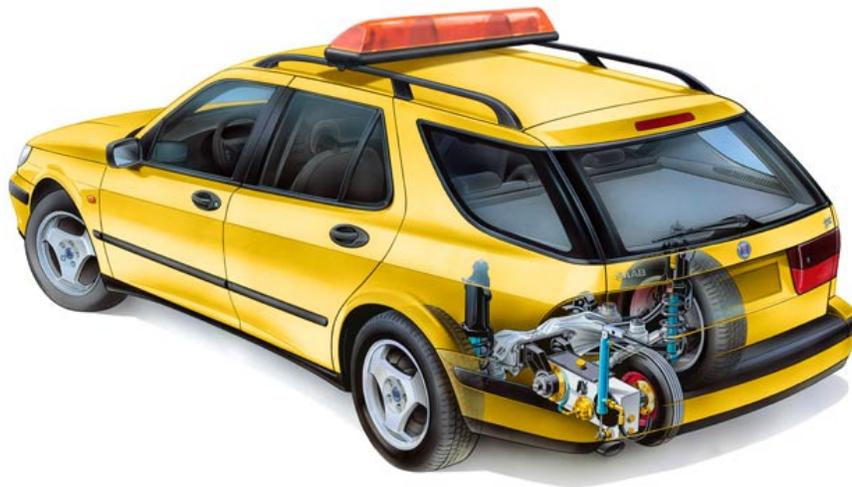
Figure 19. Sarsys Saab 9-5 Surface Friction Tester

Multiple friction test runs were conducted using a Sarsys 9-5 Surface Friction Tester, housed in a Saab station wagon. The testing took place at the FAA William J. Hughes Technical Center on HMA where two 150-foot test stripes from Manufacturers A and B were located. The ambient temperature at time of testing was 76°F, humidity was 55%, air pressure was 30.09 inches, and it was cloudy. Figure 22 shows a diagram of the test area layout where the friction test runs were conducted.

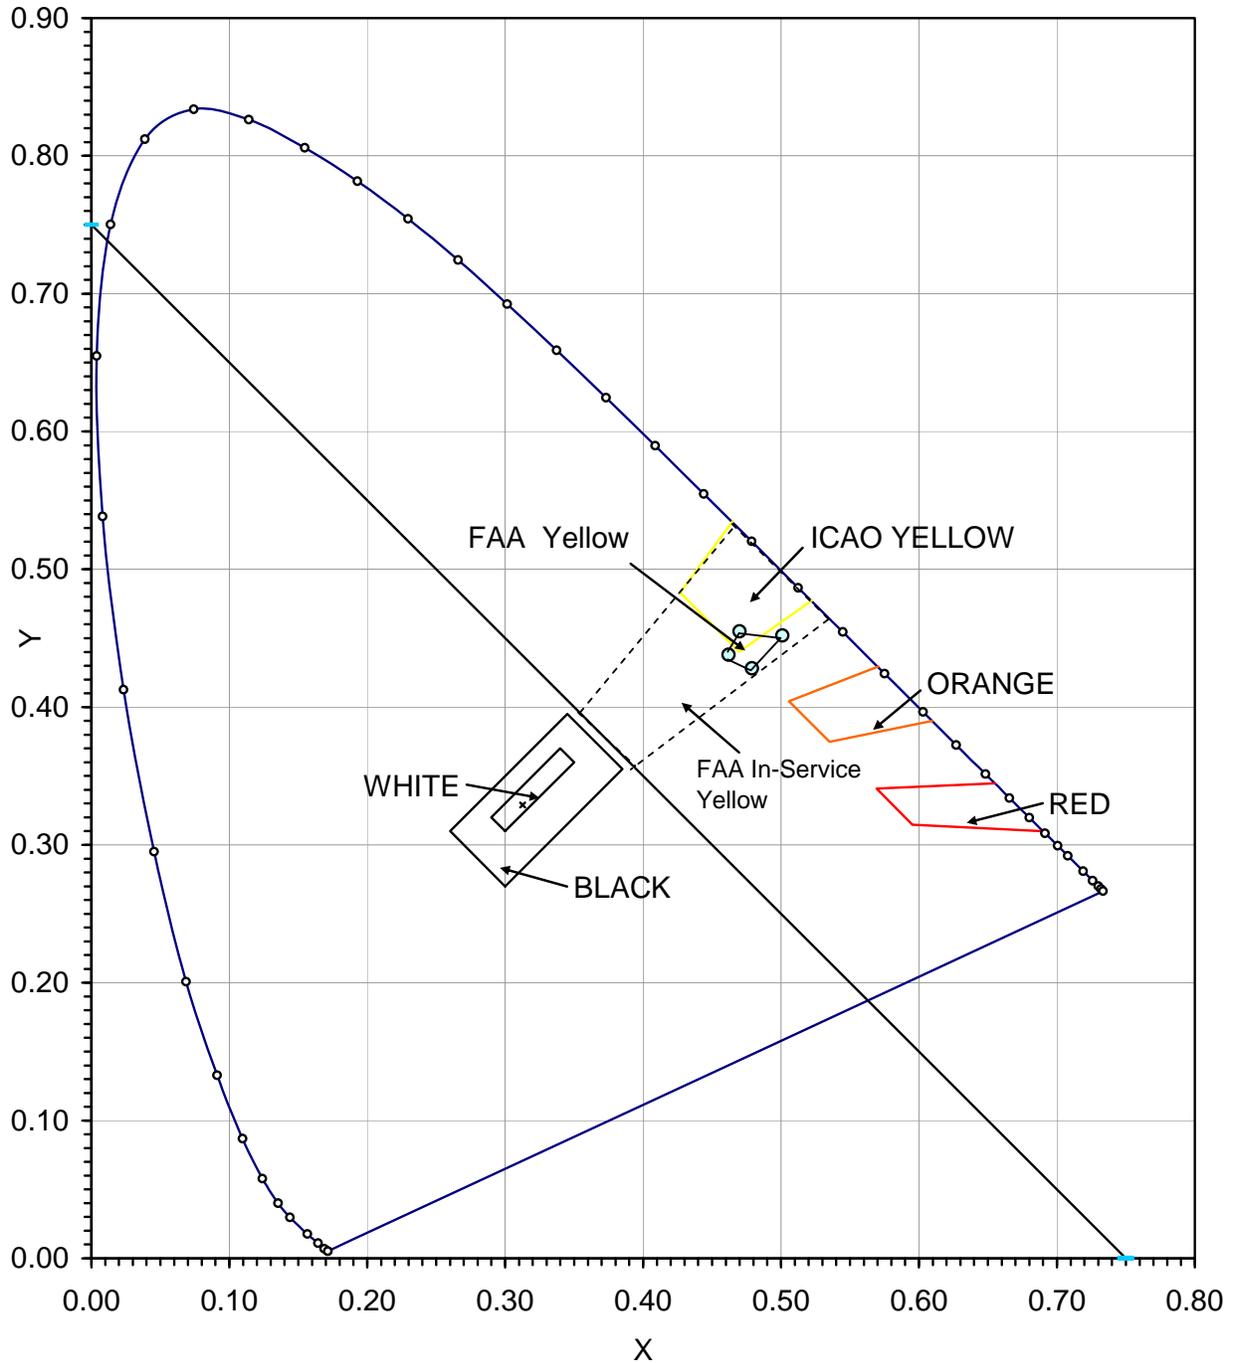
Color readings were taken with a spectrophotometer, which produced Y, x, and y coordinates for its readouts. The readings were then plotted on an International Civil Aviation Organization (ICAO) standard illuminant D65 chromaticity chart, as shown in figure 21. This chart is found in the ICAO Annex 14 Volume I—Aerodrome Design and Operations [5]. This chart was modified to address the aviation yellow used on airports. The FAA boundaries for aviation yellow are not the same as for ICAO yellow. The region for FAA in-service yellow was obtained and is documented in figure A-5 in appendix A of reference 2. The region for white is the same for ICAO and the FAA. A white data point that falls outside of the ICAO white region is considered failed. A yellow data point that falls outside of the FAA in-service aviation yellow region is considered failed.

Figure 21. Sample ICAO Standard Illuminant D₆₅ Color Chart

The acceptability range for the white x-coordinate is 0.2895 to 0.3442 and the y-coordinate is 0.3100 to 0.3650. The acceptability range for the yellow x-coordinate is 0.4261 to 0.5266 and the y-coordinate is 0.4300 to 0.5346. As shown in tables 5 through 8, a pass or fail rating was determined for each month of the 12-month evaluation. Two readings per color, per month, were tested along with the marking designation, manufacturer, and color.

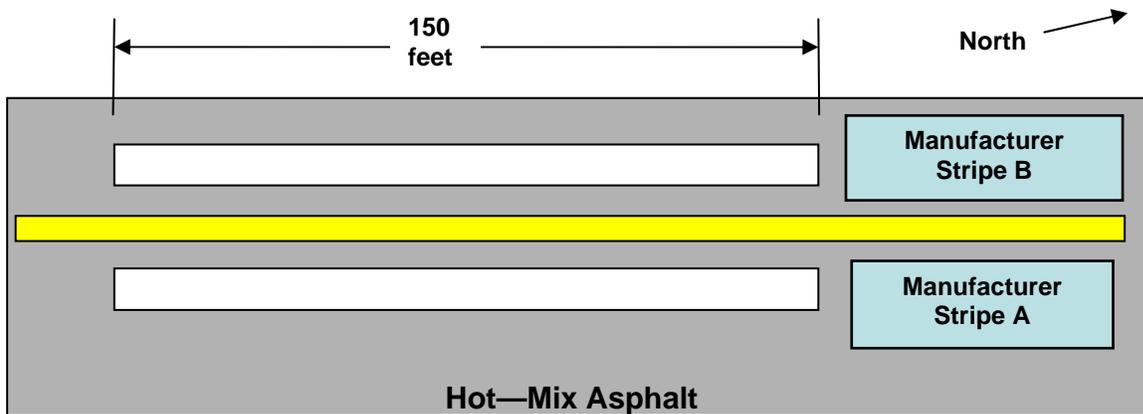
Figure 22. The HMA Friction Test Diagram at FAA William J. Hughes Technical Center

At the beginning of the test, the average friction readings on bare pavement were 0.74 μ and on thermoplastic were 0.20 μ to 0.28 μ for Manufacturer A and 0.25 μ to 0.26 μ for Manufacturer B. Because of these low friction readings, thermoplastic marking material is not currently suitable for use on runways. However, thermoplastic marking material did prove suitable for use on taxiway and apron markings and, therefore, is recommended for these applications.

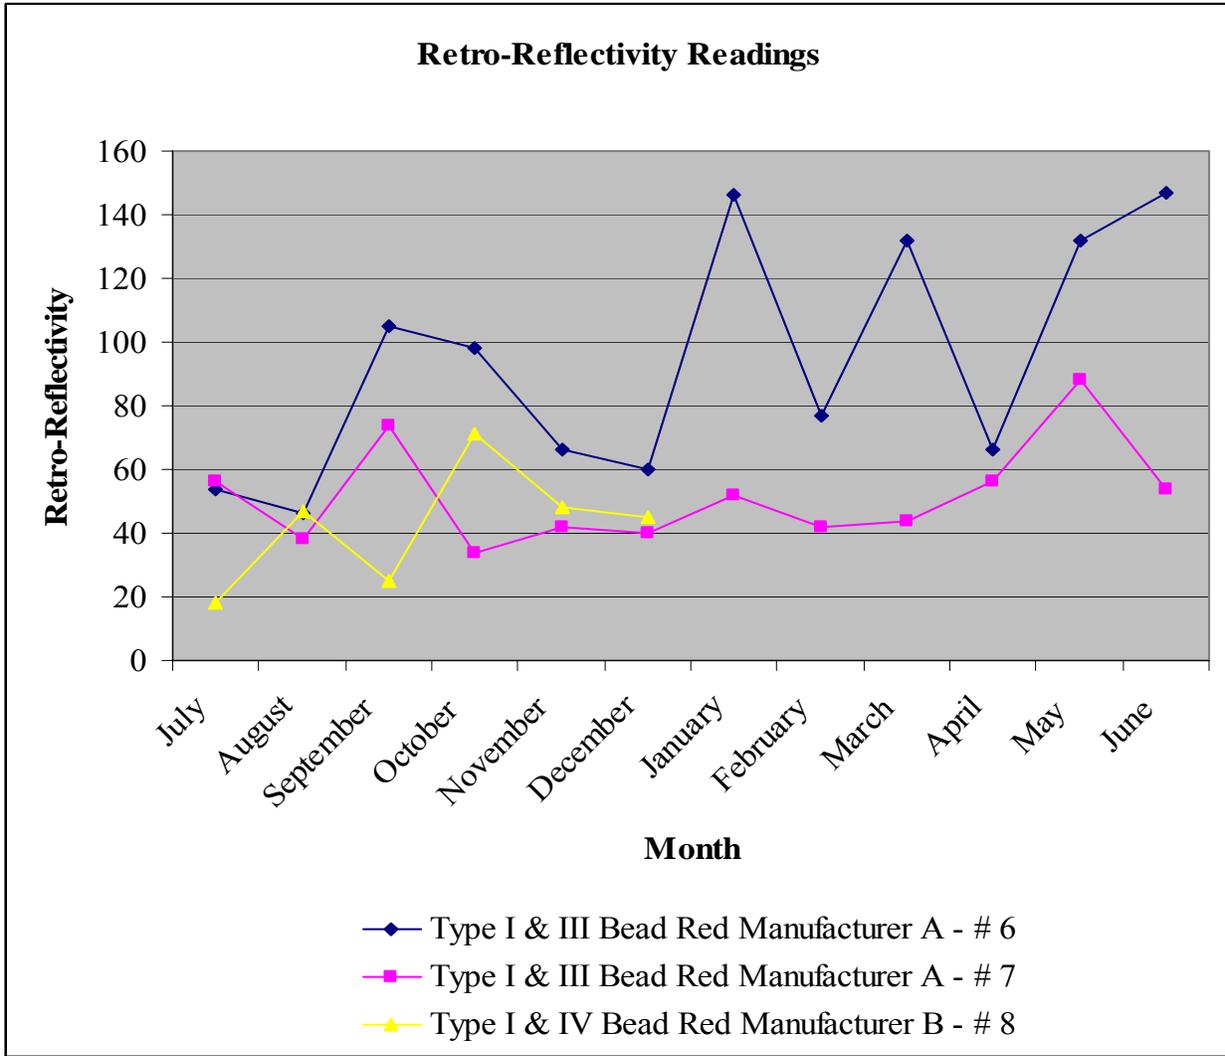
Note: All measurements in millicandela per square meter per lux (mcd/m²/lx).

Figure A-1. Graphic Display for Retro-Reflectivity Readings of Beads for Red Thermoplastic Marking Designations CCAPD6R-1, CCAPD7R-1, and CCAPD8R-2 on PCC at FAA William J. Hughes Technical Center

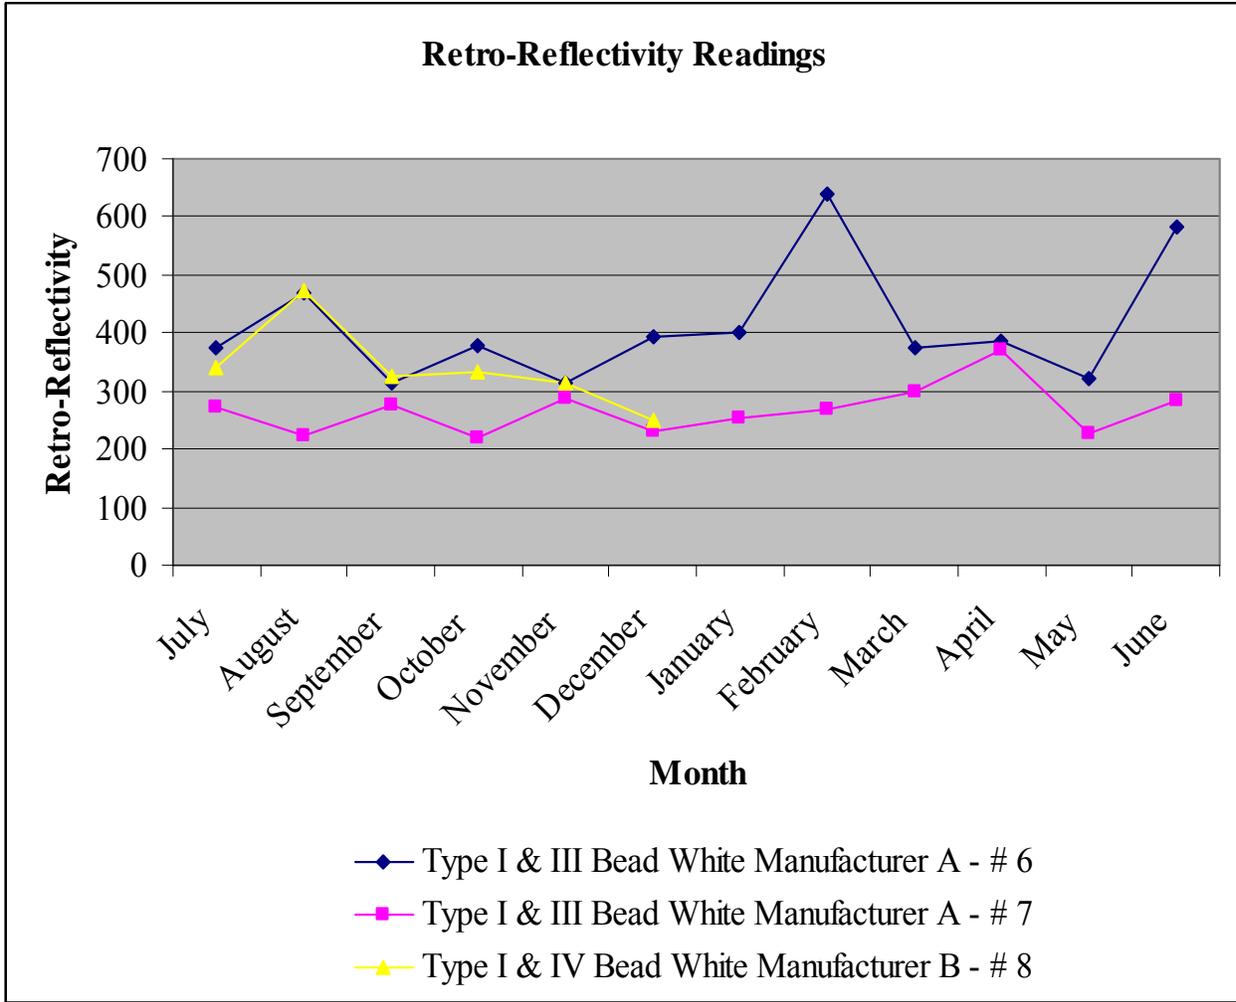
Note: All measurements in millicandela per square meter per lux (mcd/m²/lx).

Figure A-2. Graphic Display for Retro-Reflectivity Readings of Beads for White Thermoplastic Marking Designations CCAPD6W-1, CCAPD7W-1, and CCAPD8W-2 on PCC at FAA William J. Hughes Technical Center

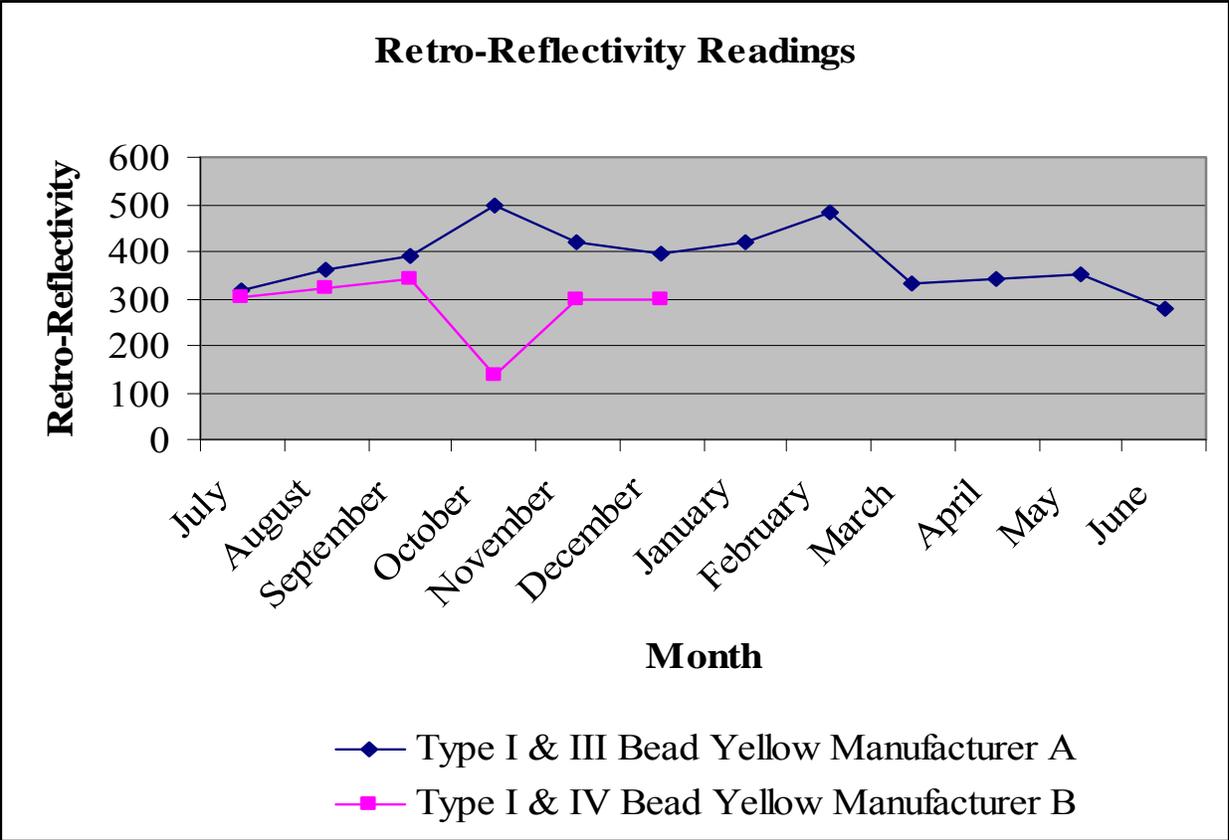
Note: All measurements in millicandela per square meter per lux (mcd/m²/lx).

Figure A-3. Graphic Display for Retro-Reflectivity Readings of Beads for Yellow Thermoplastic Marking Designations CCMNY-1 and CCMNY-2 on PCC at FAA William J. Hughes Technical Center
